DEPARTMENT OF TRANSPORTATION

Quality Assurance and Source Inspection

Contract #: 04-0120F4Cty: SF/ALA Rte: 80 PM: 13.2/13.9File #: 69.28**WELDING INSPECTION REPORT****Resident Engineer:**Pursell, Gary**Address:** 333 Burma Road**City:** Oakland, CA 94607**Report No:** WIR-007278**Date Inspected:** 06-Jun-2009**Project Name:** SAS Superstructure**OSM Arrival Time:** 700**Prime Contractor:** American Bridge/Fluor Enterprises, a JV**OSM Departure Time:** 1900**Contractor:** Zhenhua Port Machinery Company, Ltd (ZPMC), Changxing Island **Location:** Shanghai, China**CWI Name:** Chen Chih Chien**CWI Present:** Yes No**Inspected CWI report:** Yes No N/A**Rod Oven in Use:** Yes No N/A**Electrode to specification:** Yes No N/A**Weld Procedures Followed:** Yes No N/A**Qualified Welders:** Yes No N/A**Verified Joint Fit-up:** Yes No N/A**Approved Drawings:** Yes No N/A**Approved WPS:** Yes No N/A**Delayed / Cancelled:** Yes No N/A**Bridge No:** 34-0006**Component:** crossbeams and suspension brackets**Summary of Items Observed:**

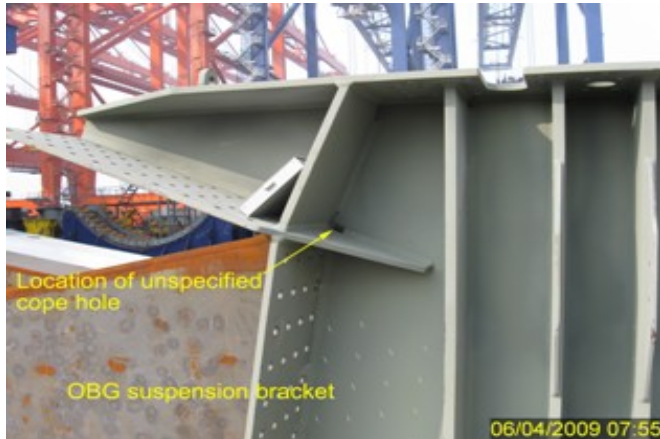
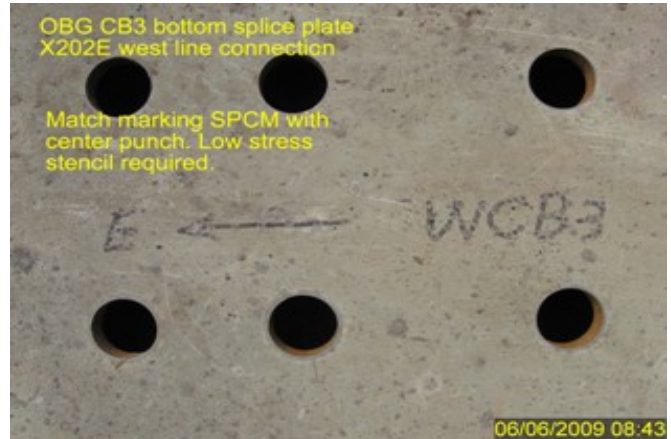
OBG cross beam CB3

This QA observed that the contractor appears to have stenciled match marking identification numbers on two SPCM splice plates using a center punch rather than the required low stress stencil. Both parts are identified as X202E. Both plates are part of OBG crossbeam assembly identified as CB3. They connect the bottom panel of the crossbeam to the east and west lines. See attached photos. AWS D1.5 2002 section 12.4.6 states "When heat

numbers and other identification markings are applied by die stamping, low-stress dies shall be used". This QA informed ZPMC QA identified as Mr. Wang Lu and ABF fabrication supervisor identified as Mr. Peter Ferguson that an incident report would be generated for this issue.

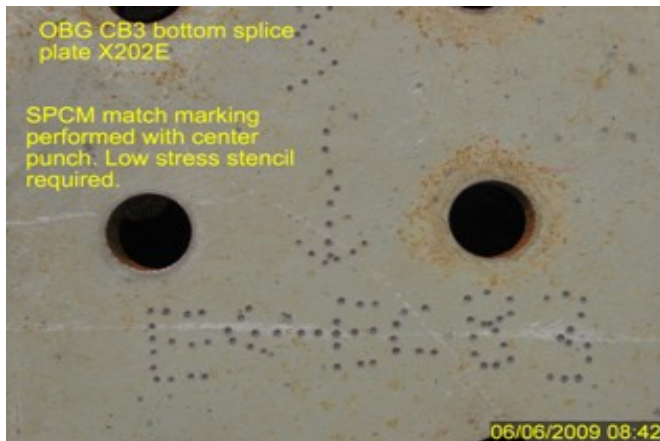
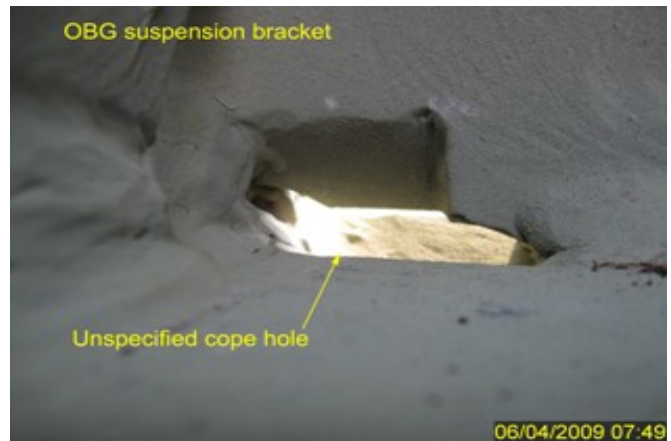
Suspension Brackets

This QA observed that the contractor appears to have a Complete Joint Penetration (CJP) weld that has not been completed or has an unspecified cope hole. The weld in question is located where the deck panel mounting flange (X53B) intersects and welds to the web plate. Shop detail drawings SB2, SB3 and SB6 do not specify a

cope hole in this area or leaving this area of this joint unwelded. This condition exists on suspension brackets identified as SB20E, SB20W, SB22E, SB22W, SB24E, SB24W, SB26E, SB26W, SB28E and SB28W. See attached photos. This issue was discussed with ZPMC QA identified as Mr. Wang Lu on 6/4/09. Mr. Wang did not provide this QA with an explanation as to why this condition existed on these brackets. This QA informed Mr. Wang Lu and ABF fabrication supervisor identified as Mr. Peter Ferguson that an incident report would be generated for this issue.
